FireFly-II/IIA Firmware 0.915 and later Description and Upgrade Instructions rev. 1.1

© 2009 Jackson Labs

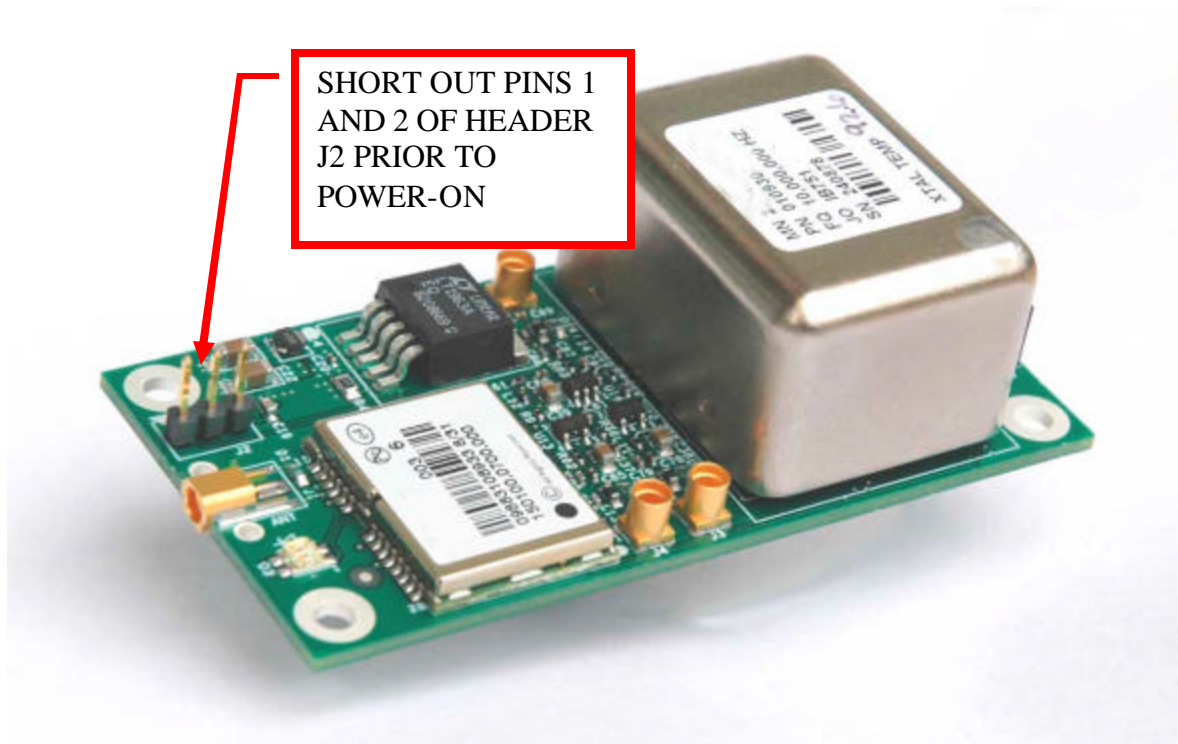
Momentarily short-out pins 1 and 2 of header J2 using a jumper, or other conductive material during power-on. Both LED's should remain off, indicating the unit is properly placed into ISP mode. If the LED's light up after power-on, the unit is not in ISP mode.

The unit has now been set to ISP mode, and is awaiting the firmware download.
